The Hit of Two Earthquakes in Turkey-Syria: $M_w=7,8$ Giziantep- $M_w=7,5$ Kahramanmaras

Citation: Cevallos, A, C., Cevallos, A, C. (2023). The Hit of Two Earthquakes in Turkey-Syria: $M_w=7,8$ Giziantep- $M_w=7,5$ Kahramanmaras. *Int J Clin Med Edu Res*, 2(4), 83-88.

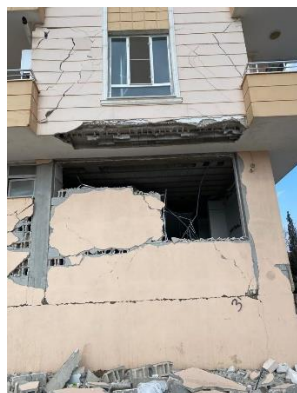
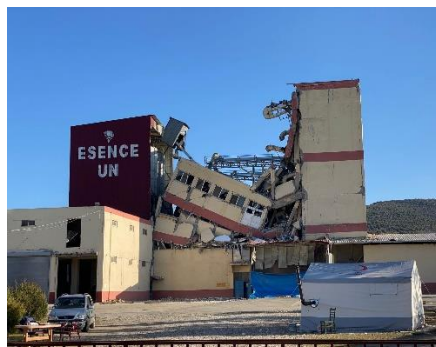
soil liquefaction, and landslides. These effects may make many areas unsafe to rebuild, so reconstruction efforts must also include decisions about what can be built and where to reduce future risks. Resilient infrastructure is patchy in southern Turkey and not so far in Syria; one of the reasons why the extraordinary number of victims has been so high is the poor quality of buildings Figure 3.

Figure 3: Structural fail occurred by a bad quality of materials and odd construction code

acceleration. The overlaid spectrums clearly indicate that collapse expectations for mostly mid-rise buildings (five- twenty stories). Many of the buildings were built before the 2000s causing around 40,000 buildings collapsed (for now) by the EQ_s . Consequently,

those buildings were designed on old Turkish construction code. They did not provide enough reinforcement (rebar's are expensive) for the ductility that they relied on. Therefore, the buildings did not provide performance in the plastic region.
