# Cables Scab, A Scientific Characterization of The Degradation of XLPE and HV/HR-PVC Insulation Under the Influence of Ultraviolet Radiation and Excessive Mechanical Stress in An Environment Extremely Hostile to Polymers

Prof. Hazar Shtat\* - Jordan

**Citation:** Shtat, H. (2025). Cables Scab, A Scientific Characterization of The Degradation of XLPE and HV-PVC Insulation Under the Influence of Ultraviolet Radiation and Excessive Mechanical Stress in An Environment Extremely Hostile to Polymers. *Eng OA*, 3(8), 01-03.

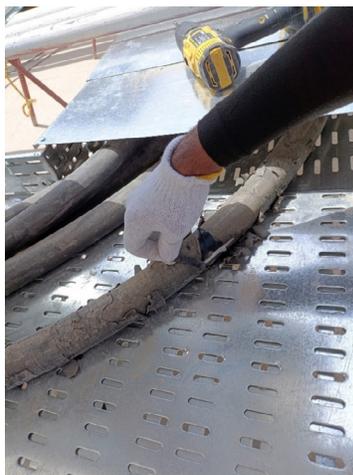
**Figure 1:** A Picture of Insulator Being Damaged Due to Excessive Mechanical Tension and Extreme Heat, Which Is Beginning to Affect the Adjacent Cables

Cable scab is a condition characterized by the gradual deterioration

of the insulation of electrical cables, characterized by gradual peeling, discoloration, and brittleness without any immediate electrical failure.

- Tears in the outer jacket
- Unnatural creases or folds
- Changes in cable cross-section

- Excessive pulling forces
- Absence of rollers for pulling and tightening
- Insufficient lubricants
- Pulling on sharp corners or directly onto the ground
