Retrograde Looping of Peripherally Inserted Central Venous Catheter

Case Study

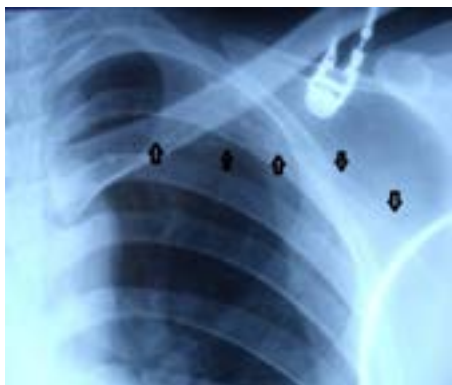
Intra-operatively, all the vital parameters of the patient were normal except a high central venous pressure (CVP). Since the patient had no preoperative cardiovascular abnormality and intraoperative IV fluid was administered judiciously, we suspected possible PICC malposition. We tried to correct the PICC position intraoperatively by inserting a guide wire and with saline flush but failed.

Figure 1: Chest X ray showing retrograde coiling of PICC.

Intra-operatively as it was difficult to obtain another central venous access and all the other vital parameters were normal we left the PICC in-situ. Postoperative chest x-ray (CXR) of the patient showed a retrograde coiling of the PICC in the axillary vein (AV) (Figure 1).

We removed the PICC and placed a new PICC through right basilic vein, correct position of which was confirmed with CXR.
