Satellite-Based Flood Inundation and Damage Assessment

Because recurring floods in the Philippines have become more damaging throughout time, risk assessments, quantifying, and visualizing flood damages as accurately as possible become imperative. To deal with an up-to-date database and a practical assessment tool, a satellite imagery-based method was used which aimed to map flood inundation and estimate damages brought by the flood during Typhoon Ulysses. This paper presents a framework for an integrated flood risk management in a river basin context with the following components as follows: 1) collection of the comprehensive database containing information relevant for flood analysis; 2) use of a satellite-imagery based method for flood inundation map using Google Earth engine; 3) validation of map accuracy through quick post-flood participatory approach. Analysis of the recent flood inundation event in November 2020 in Cagayan Valley, Philippines showed the inundation of an extensive area of 620.88 km² affecting the Cagayan province at 55.91% and Isabela province at 44% share of inundation. The flood severely affected approximately 614.05 km² of the total croplands. Using a par

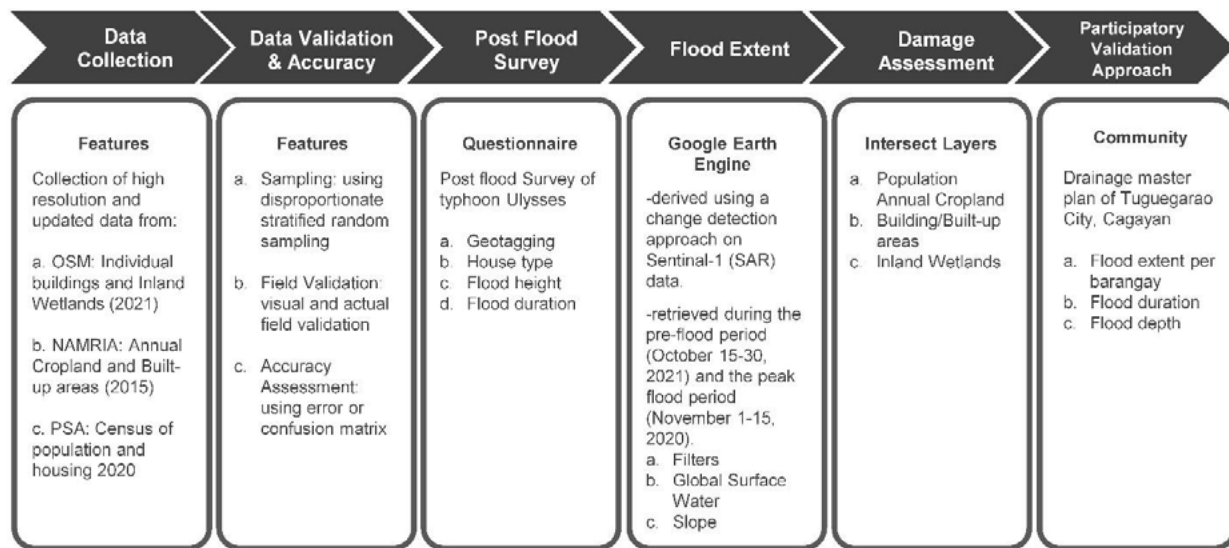
Figure 1: A summary of the overall methodological framework used in the study

Figure 1 depicts the overall methodological framework used in the study. Two validations were performed: for datasets and flood extent. A post-flood survey was conducted to determine the threshold for estimating flood extent in GEE. Flood maps and flood-risked resources were quantified and tabulated. Validation of map accuracy through a quick post-flood participatory approach was done. A step-by-step procedure was presented for future replication of the study.

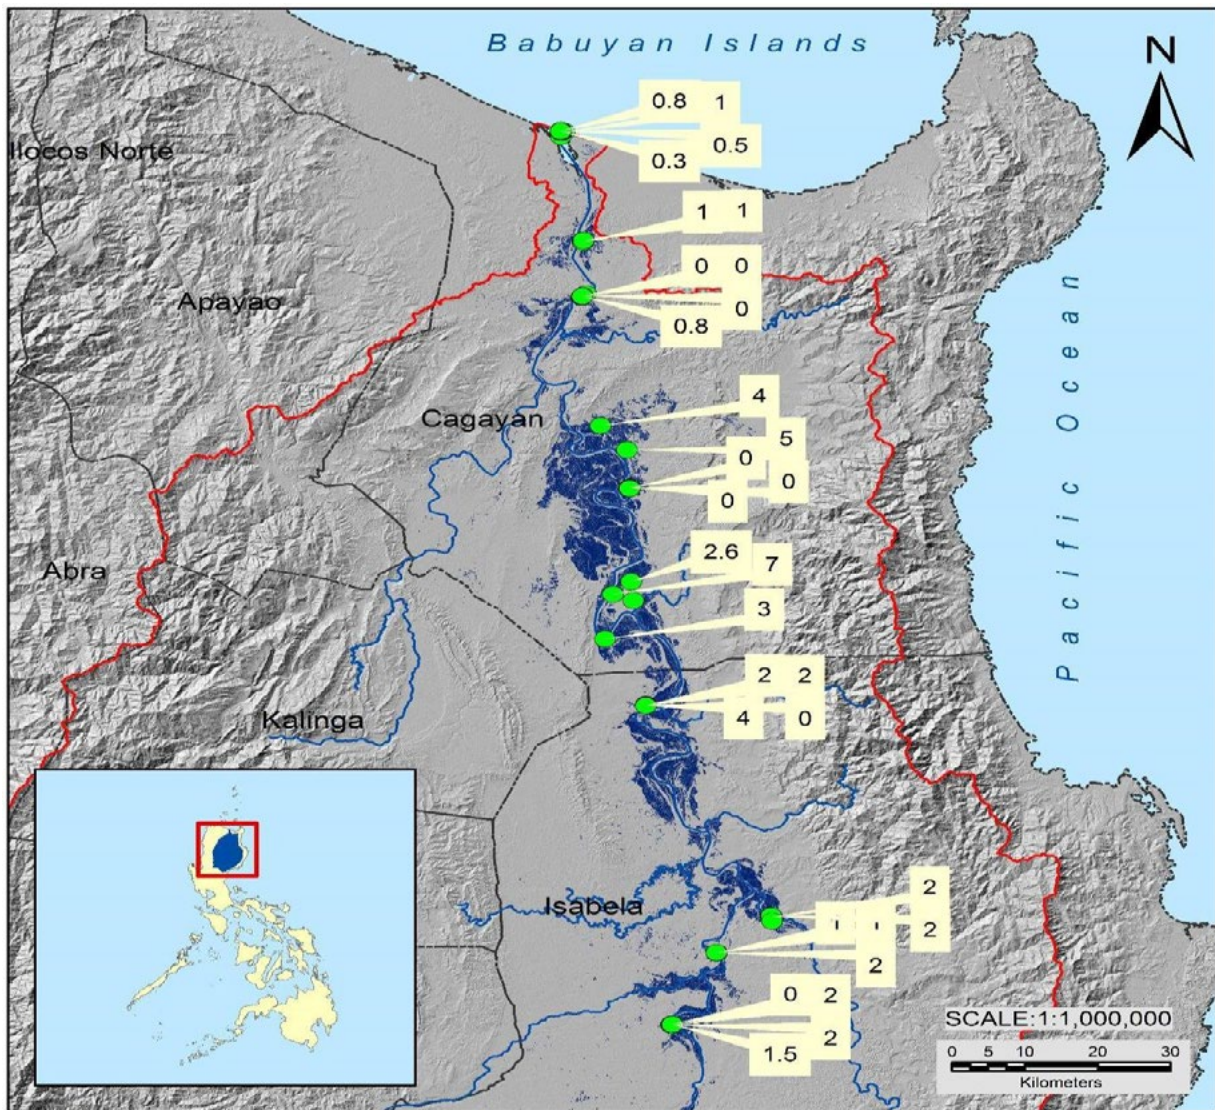
Figure 2: Locations of households (green dots) interviewed during the post-flood survey of typhoon Ulysses showing the flood depths. Those with a zero value indicate that no flooding happened in that specific location.

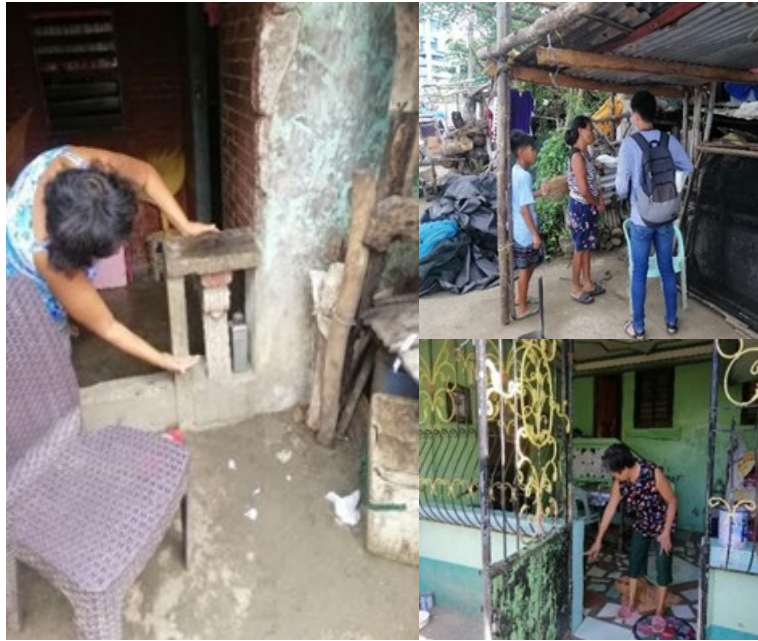
Figure 3: Ground photographs of sites where households were asked information such as flood duration and flood height to indicate water levels during flooding.

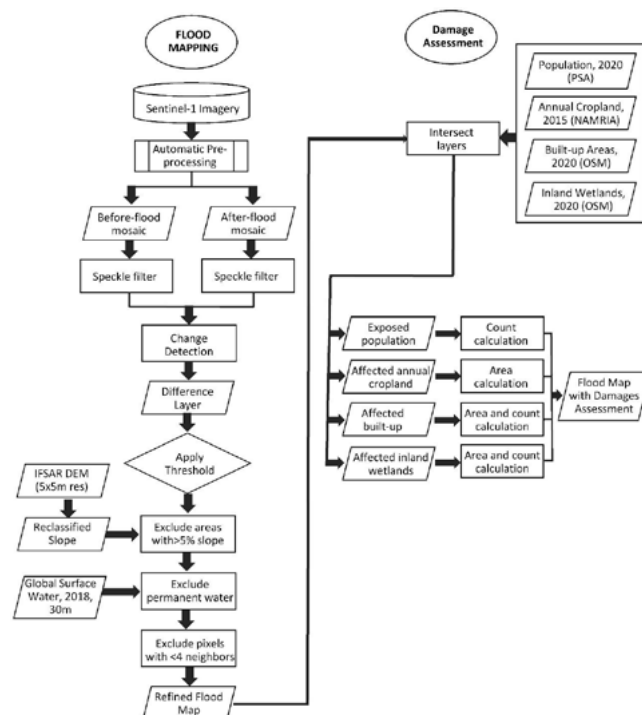
Figure 4: Workflow of flood inundation using GEE and damage assessment in ArcGIS. The high-resolution datasets like DTM for slope and land cover maps were the two main inputs altered from the default dataset used by GEE.

Detailed workflow of flood extent derivation using GEE is shown in Figure 4. The workflow was based on the recommended practice developed by [13]. Flood inundation was derived using a change detection approach on Sentinel-1 (SAR) data. The Sentinel 1AVH polarization images were retrieved during the pre-flood period (October 20, 2021) and during the flood period (November 13-

16, 2020). The various pre-processing techniques including radiometric calibration, removal of noise, and orthorectification were performed. The threshold of 1.10 was applied to deduce the flood hazard in the lower basin. The Global Surface Water dataset (2018, 30m resolution) was used to mask areas covered by water for more than 10 months.

In this study, IFSAR DTM of 5-m resolution was used to derive slope instead of World Wildlife Fund WWF HydroSHEDS hydrologically conditioned DTM which is based on Shuttle Radar Topography Mission (SRTM) and has a spatial resolution of 3 arc-seconds. To estimate the damage that occurred due to flood, elements discussed earlier like population, built-up, croplands, and inland wetland were intersected. The area and/or count of each inundated land cover was calculated and tabulated. This was done for all barangays affected. It should be noted that the damages were evaluated in a river basin context.

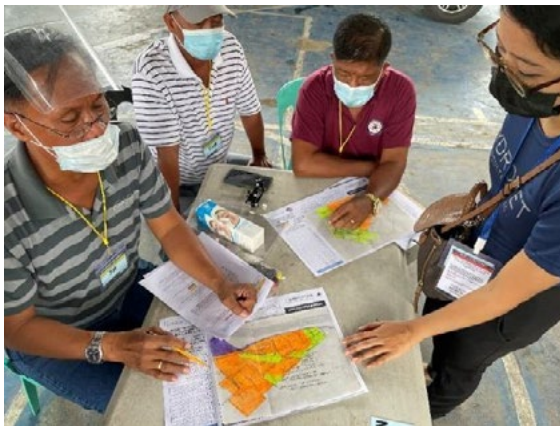
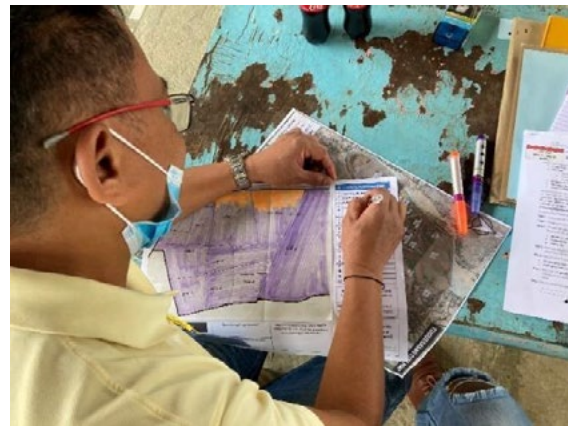
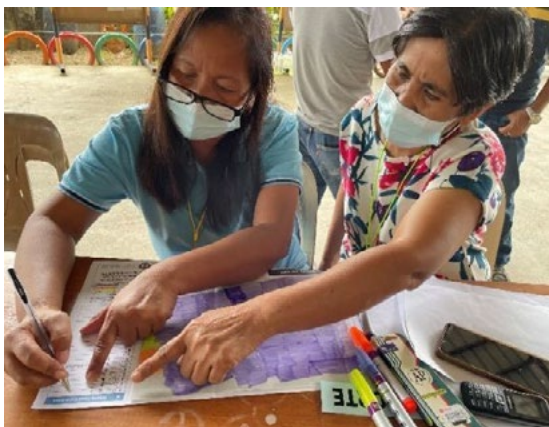
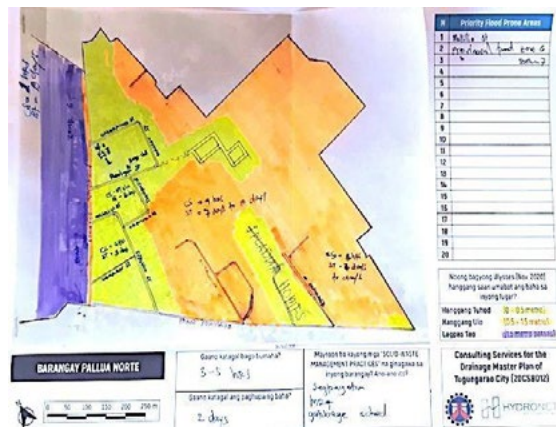
Figure 5: Representatives from barangays (a), (b), (c) identify the subsidence and duration time in their area, and a sample color-coded flood depth map (d)

oration with Hdronet Consultancy, Inc. and barangay officials, mapped flood extents where they were instructed to assign appropriate colors to each region of their barangay-based on Typhoon Ulysses' results. Important areas wherein floodwater originates (Cagayan River, Pinacanan River, and open drainage system) were explained to the participants for easier mapping. When they finished assigning colors and identifying important facilities and routes in their respective barangays, they were then tasked to list the priority areas which are usually flooded. Figure 5 shows the barangay personnel identifying the extent and time concentration of flood during typhoon Ulysses.

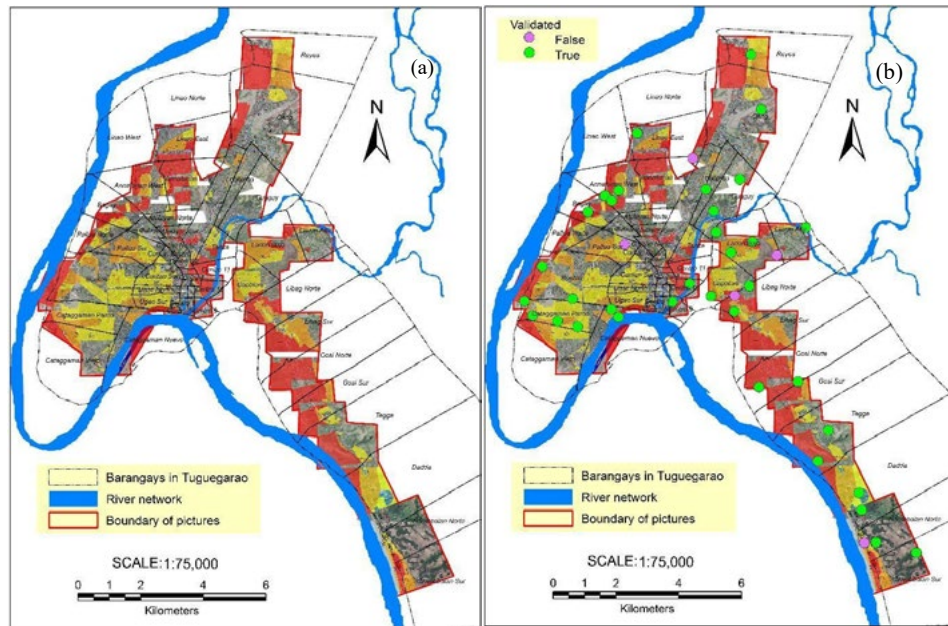
Figure 6: Tuguegarao City featuring the (a) georeferenced flood maps and (b) sampling points (circle dots) for validation of flood extent (light blue) using GEE.

The consulting agency carefully digitized the output maps in Google Earth producing laid-out maps in JPEG format, which were then georeferenced by our group for flood extent validation us-

ing GEE. Figure 6 shows the georeferenced photos and sampling points for validation of flood extent using GEE.

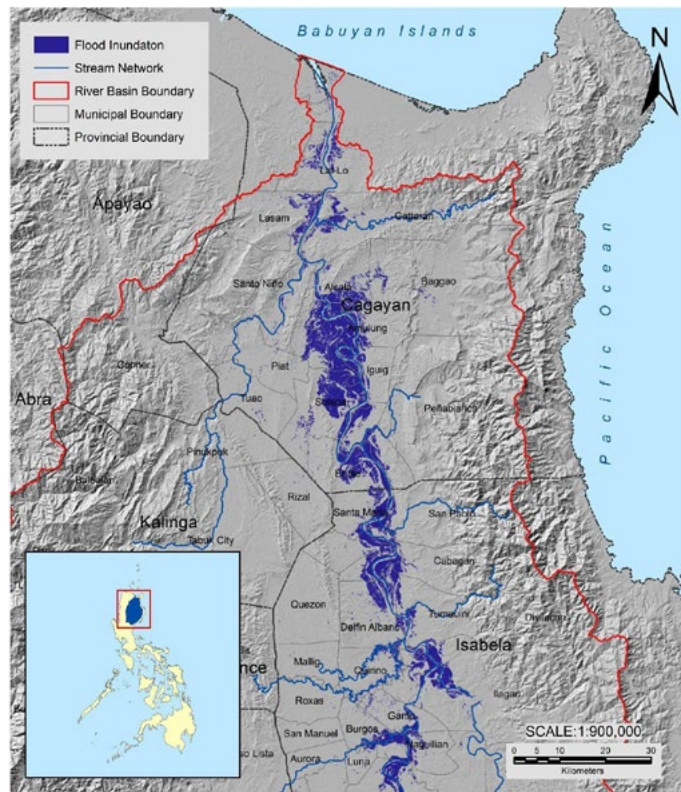
Figure 7: Final flood inundation map of typhoon Ulysses using GEE showing the terrain and provinces affected

(Figure 7) dented by blue overlaid on the administrative boundaries of the region and the affected land cover map (Figure 8) were created with a total area of 620.88 km². The flood was most densely distributed along the low-lying stretch of the Cagayan River.

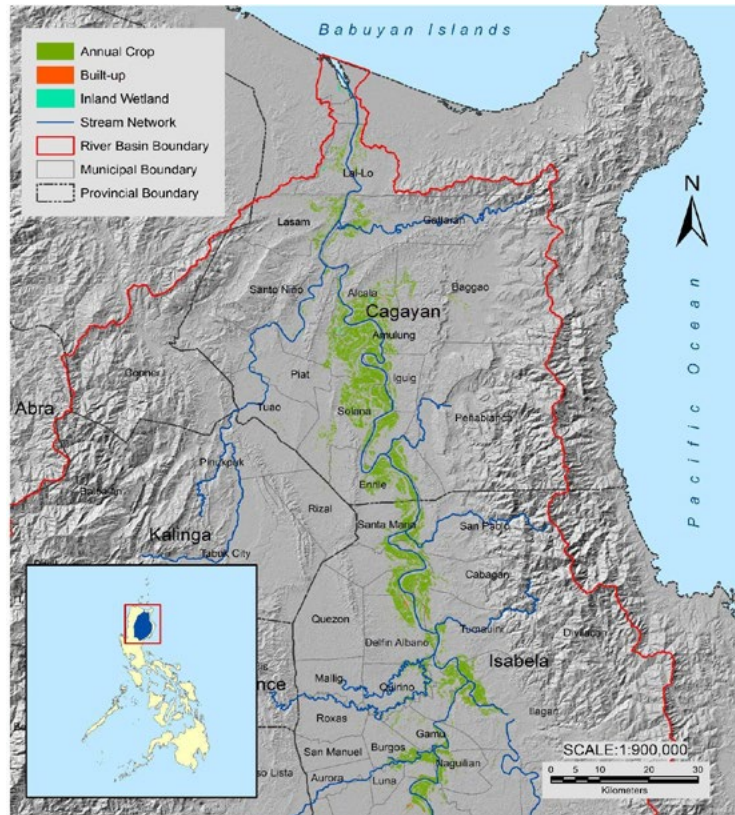
Figure 8: Affected land cover in Cagayan River Basin during the flood due to Typhoon Ulysses

safer site and situation. The use of satellite-based flood inundation analysis like GEE will aid in the identification of the worst-affected districts in terms of submerged areas. Of the land classes listed, annual cropland was the most affected (98.90% of the total inundation), followed by built-up (1%) which affected a large population (~ 225,634). Therefore, it is critical to focus on lowering damage in annual croplands.
