Solving Manufacturing Problems with 8D Methodology: A Case Study of Leakage Current in a Production Company

Khalid Mahmood

Citation: Mahmood, K. (2023). Solving Manufacturing Problems with 8D Methodology: A Case Study of Leakage Current in a Production Company. *J Electrical Electron Eng*, 2(1), 01-18.

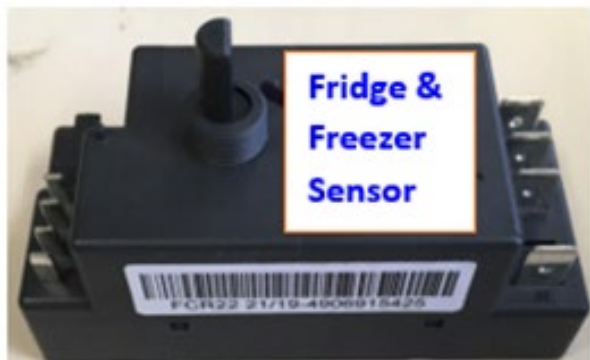
Figure 1: FCR Sensor Overview

This research paper presents a case study of the techniques used by manufacturing suppliers in Thailand and China to address problems in the production of fridge-freezer temperature controllers and sensor units. The device is shown in Figure 1: FCR

Sensor Overview, and the location of the MLCC (PCB Component C11) that is the focus of the investigation is indicated by the arrow in Figure 2: Location of the affected capacitor.

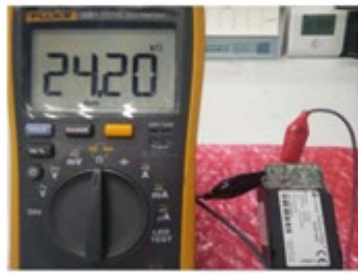
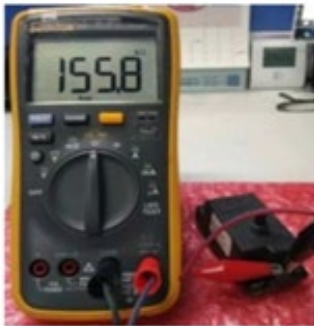
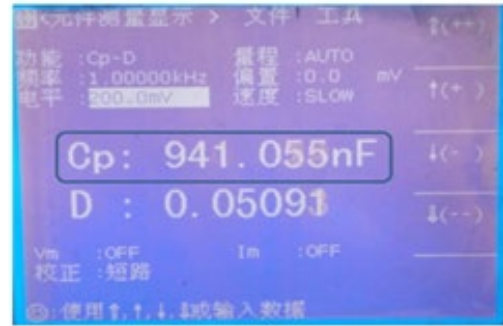
Figure 11: C11 MLCC Failure

As part of the 8D investigation process, it is standard practice to measure the resistance between T8 and T9 on returned samples. In this case, the resistance of returned sample SN1 had decreased, but the resistance of returned sample SN2 was within normal limits when compared to a known good sample unit. This information was used to identify potential causes of the issue and implement appropriate corrective actions.

potting material were removed to expose capacitor C11. The resistance between T8 and T9 was found to be abnormal, but was corrected after replacing C11 with a new capacitor.

The original capacitor was then measured with an LC meter and found to be within the specification listed in the datasheet ($1\mu\text{F}\pm 10\%/25\text{V}$). No cracks were observed on the capacitor, as shown in Figure 11: C11 MLCC Failure. This information was used to identify the root cause of the issue and implement a corrective action.

At not OK condition

Replacing with a new capacitor

The resistance returned to normal

The capacitance was measured at 0.94uF within the spec for C11
