Successful Practical Case Studies Solved at our P&U, NRL

2. Case Study-I : “A Very Interesting, Peculiar and Mysterious Observations of STG CT H₂SO₄ Acid Overhead Dosing Tank”

3. Case Study-II: A Study on “UB tripping on SCAF pr. low-low trip alarm actuation during Total Power Failure scenario”

4. Case Study-III: Study of “Cause of Heavy hammering problem of CPP De-aerator and subsequent solution to root out the problem”

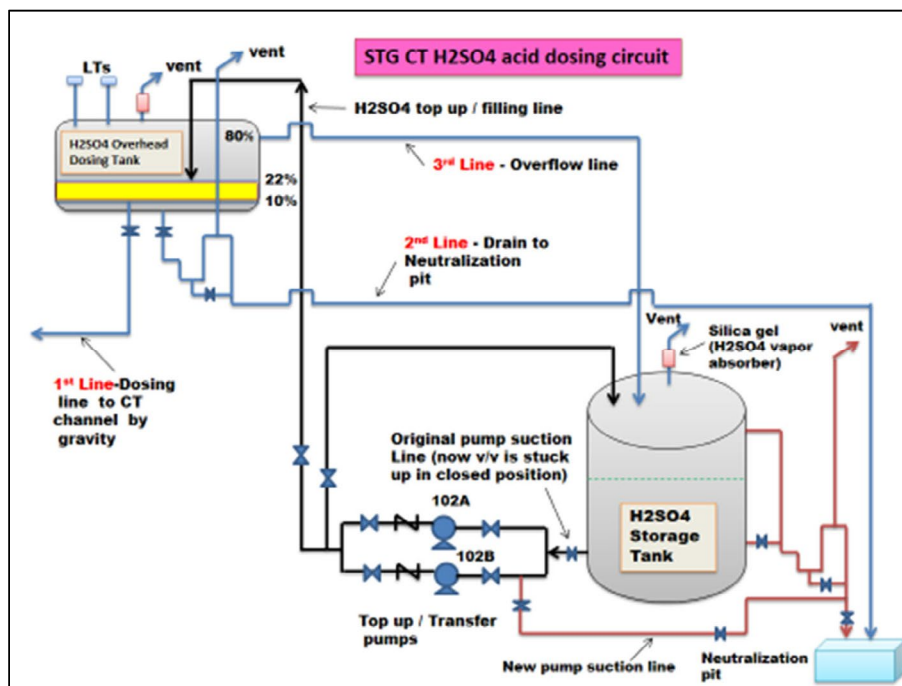
Figure 1: STG CT H2SO4 acid dosing circuit

At Steam Turbine Generator (STG) Cooling Tower (CT), we have sulphuric acid (H2SO4) dosing system to maintain Cooling water pH. The overhead dosing tank located at about 13 metres height from the ground level is topped up by two nos. of top-up or transfer pumps (102A & 102B) from the H2SO4 storage tank allocated at ground level. The original pump suction root isolation valve is stuck-up in closed condition. So, a new pump suction line is fabricated which is shown and indicated by maroon colour line in the above picture Fig-1.

The overhead dosing tank has 3 main outlets viz. - 1st line is the dosing line going to CT channel by gravity; 2nd line is the drain line to the Neutralization pit and the 3rd line (taken from about 80% level of the dosing tank) is the overflow line going back to the storage tank.

Diagram (Fig-1) is Attached Above for Reference.

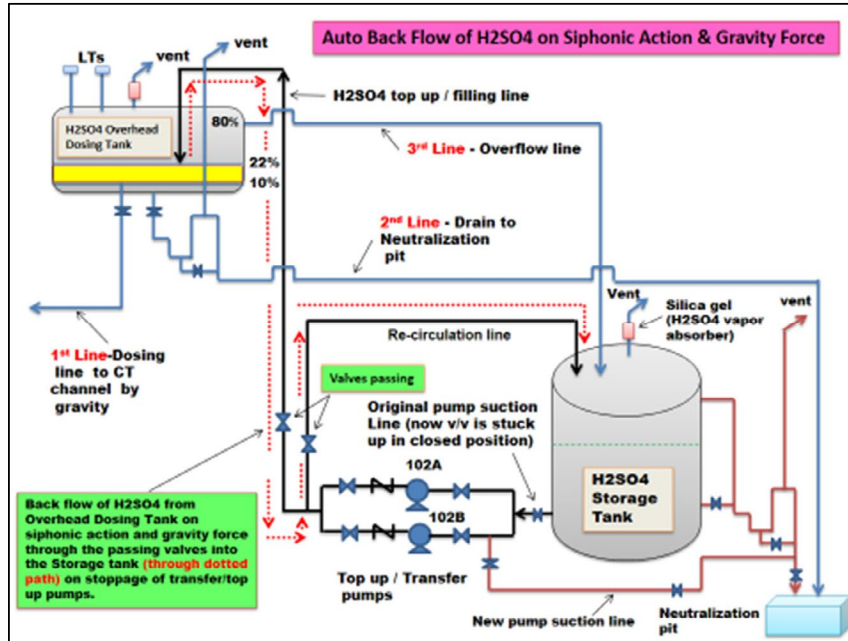
- Reason: The H₂SO₄ transfer/top pumps discharge line/filling line which enters into the overhead dosing tank is extended inside the overhead dosing tank approx. to about 22% level of the dosing tank. When the pumps are in service, the H₂SO₄ goes to the overhead dosing tank and also simultaneously to the storage tank through the pump re-circulation line due to passing valve. So, as soon as the transfer pumps are stopped, the liquid column pressure build up inside the overhead dosing tank due to rise in liquid level inside it; results in the siphonic action on the already filled in H₂SO₄ in the filling line/pump discharge line and pump re-circulation line, the H₂SO₄ automatically goes back to the storage tank till 22% is reached at the Overhead dosing tank by the siphonic action and further aided by the gravity force (which is because the overhead dosing tank is situated at a higher position of about 13 metres than the storage tank at ground floor). After that 22% level, the level of H₂SO₄ comes below the final discharge point of the pump filling line. So air enters into the filling line and breaks the siphonic action and breaks the automatic continuity of H₂SO₄ flow through the siphonic and gravity forces/actions and thus we could see that the overhead dosing level comes down and become stable at 22%.

Figure 2: Automatic back flow of H₂SO₄ from Overhead Dosing Tank to Storage Tank

- The H₂SO₄ of the overhead dosing tank flows back into the storage tank till 22% level of the overhead dosing tank is reached; through the pump filling line's common valve passing and through the pump recirculation line valve passing and finally into the storage tank; by the siphonic action and gravity force; caused by the rise in the liquid column inside in the overhead dosing tank on filling and positive difference in the height of the overhead dosing tank and the storage tank.

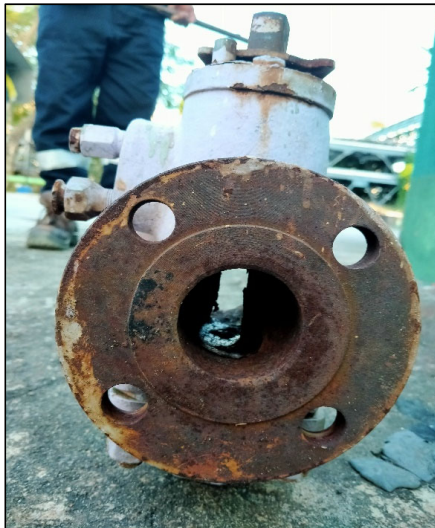
- On opening for checking and maintenance purposes, both the recirculation line isolation valve (fig-4 below) and also the pump discharge common header line isolation valve were found passing (fig-3 below) as the gates of these valves were found corroded and damaged due to the H₂SO₄ acidic corrosion.

Figure 3: Pump common discharge iso valve

- Both these damaged and passing valves of the pump discharge/ filling common line valve and recirculation line valve were replaced with the new isolation valves.

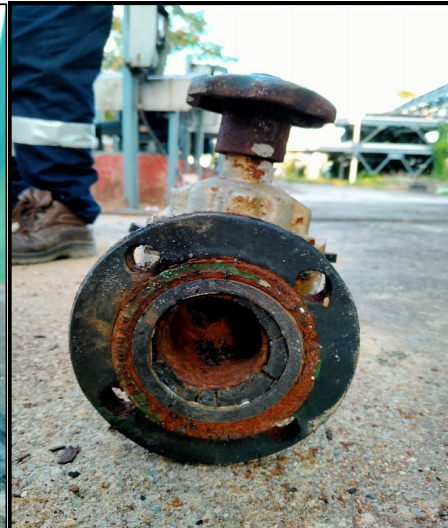
Figure 4: Pump recirculation iso valve

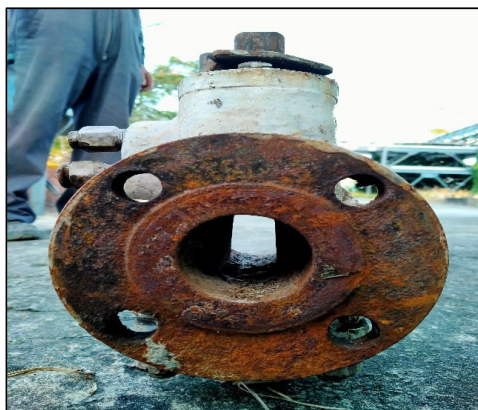
- The original pump suction line connected to the pump suction root isolation valve or the storage tank root isolation valve gate was found stuck up while opening for it's checking. It's gate was found detached with the valve spindle. It could not be opened or closed. It was found heavily jammed. This damaged and jammed root isolation valve was also replaced with a new isolation valve.

Figure 5: Pump suction root iso valve

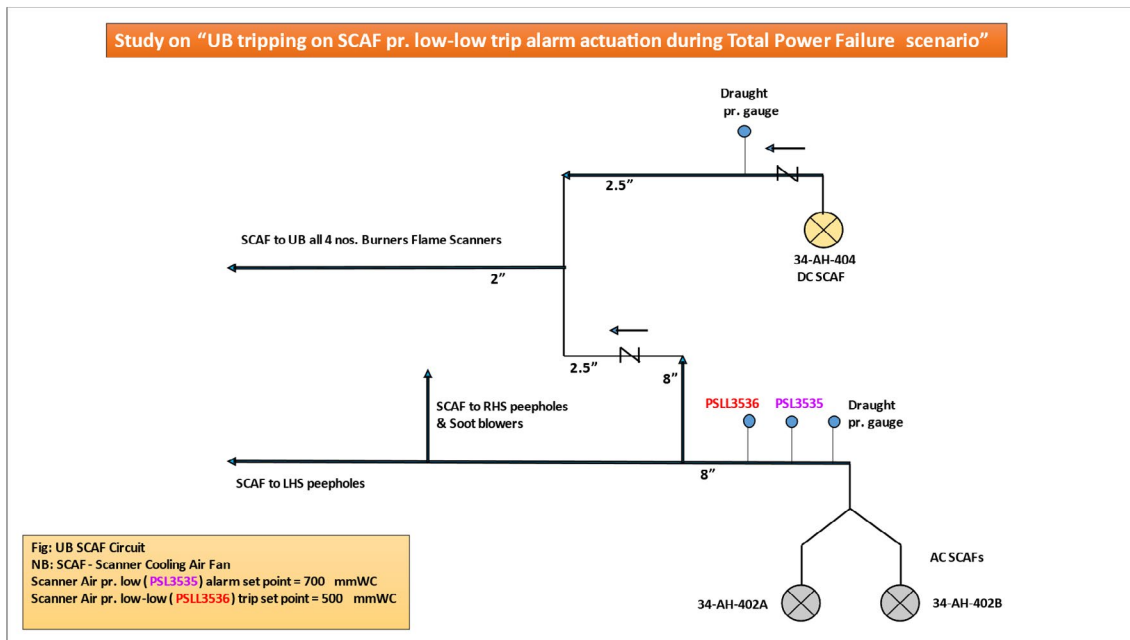
- From the UB SCAF circuit diagram (Fig-1 below), the DC SCAF gives discharge to only UB Burners scanners so that sufficient cooling air is ensured to the flame scanners during Total Power failure and tripping of AC SCAF to protect the flame scanners from damage.

- There is a NRV towards SCAF AC header. This does not allow the DC fan flow from going towards AC SCAF circuit where the SCAF pr. switches are located.
- The DC SCAF must go towards this AC SCAF circuit to normalize back the pr. switch low PSL3535.
- As the NRV obstructs the DC SCAF towards the AC SCAF circuit,

Figure 1: UB SCAF Existing Circuit

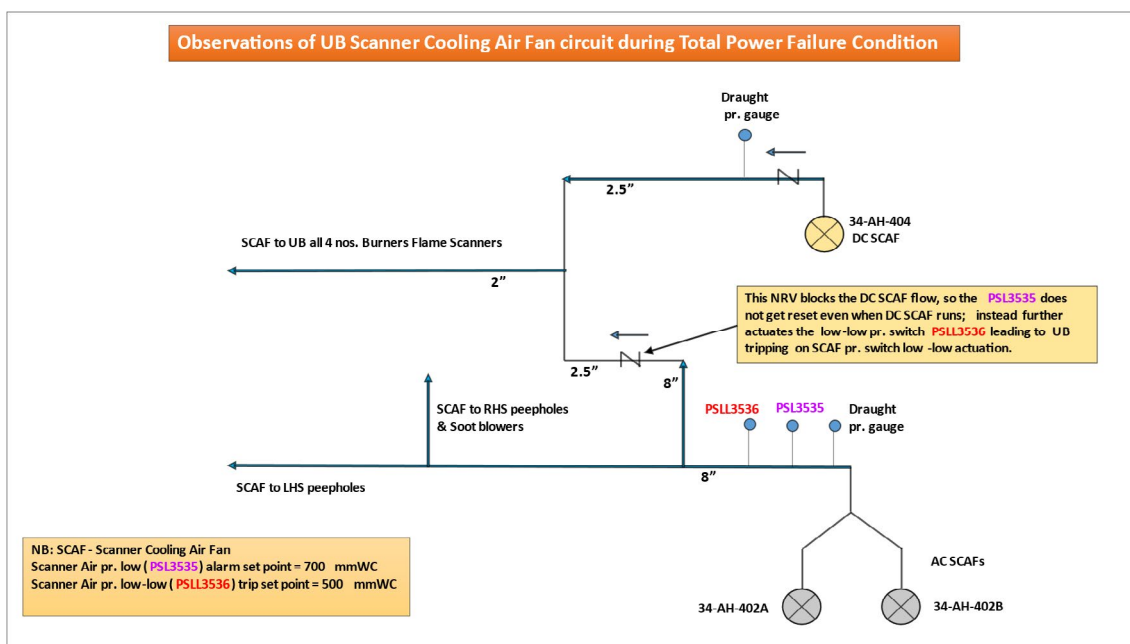
so the PSL3535 does not get reset, instead further actuates the low-low pr. switch PSL3536 even though the DC SCAF is running perfectly healthy. This ultimately leads to UB tripping on SCAF pr. switch low-low actuation.

Figure 2: Explanation or Cause of UB Tripping on Tripping of AC SCAF

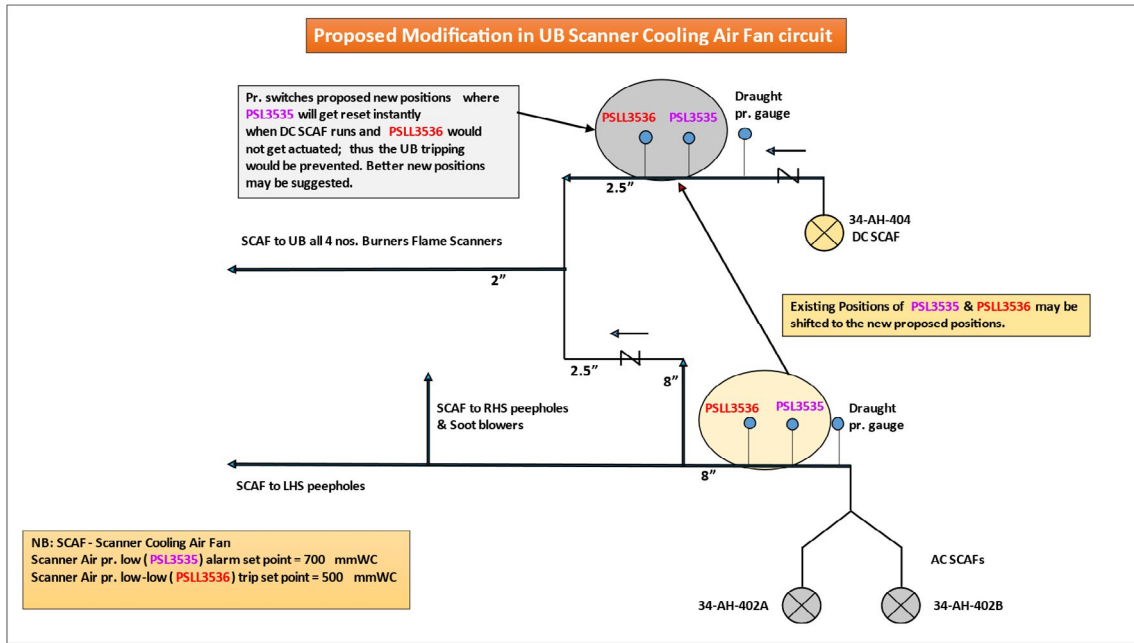
Figure 2: Modifications to avoid UB Tripping on Tripping of AC SCAF

- To install those low & low-low pr. switch on DC SCAF header just near it's discharge draught pr. gauge before it's NRV (or downstream of the DC SCAF NRV, shown in the fig-3).
- This will help to instantly normalize the low pr. switch PSL3535 which then get reset whenever the DC SCAF gets auto started. Thus, this prevents the actuation of low-low SCAF pr. switch PSL3536 and thus prevents the UB tripping.
