Valuable Experiences & Learnings from the Rare, Unsafe & Hazardous Fire Incidents in our Power & Utility, NRL

Bijit Kumar Borah, Hriday Ranjan Kalita and Dinesh Brahma*

Numaligarh Refinery limited, CPP Control Room, Power & Utility Department India

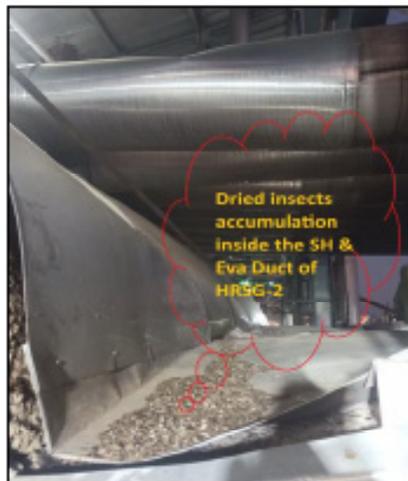
Figure 1: Dried Insects Accumulation Inside the Hrs-g-2 Sh & Eva Insulation Cladding Sheets

It was observed that huge pile of dried (dead) insects which was concealed/hidden inside the insulation cladding gaps & inside the insulation materials. Also, we noticed a long approx. foot (300 mm) crack at the bottom of the SH & Eva Duct Zone surface. Insects are drawn to hot air currents & area lights which glow during the evening & night hours. Overtime, these insect remains dry out, forming a carbon-rich flammable layer. These remains got deposited inside the hot insulation gaps, duct interiors, hot SH & Eva surfaces. Contact with the hot flue gas temperatures > 400 deg C coming out through the crack of the SH/Eva Top Duct Surface ignited the insect matter. This led to the burning of these insects and resulted to the fumes/smokes.

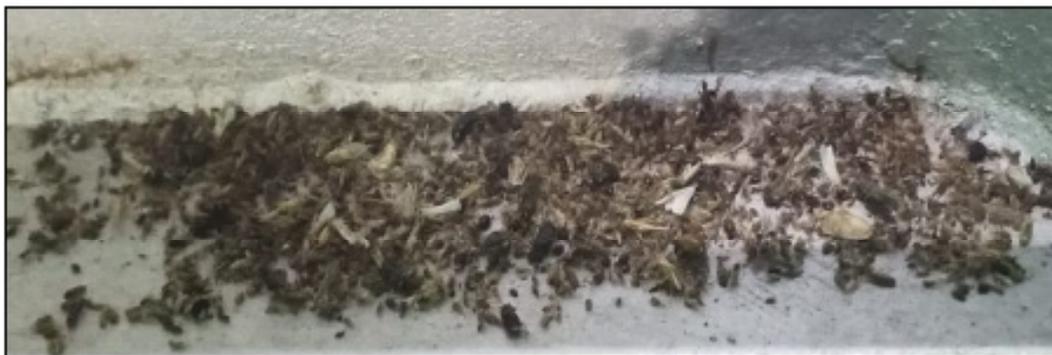
Figure 2: Dried Insects/Organic Accumulation Inside the Hrs-g-2 Sh & Eva Insulation Cladding Sheets

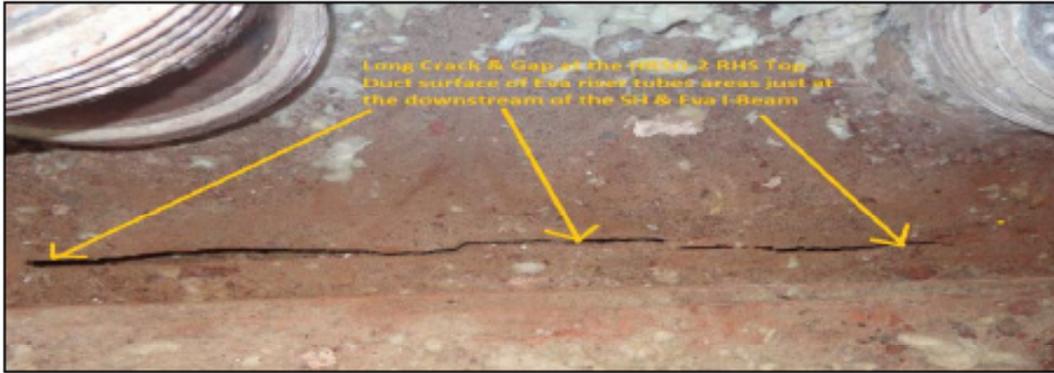
Figure 3: Approx. 300 mm long Crack Inside the HRSG-2 SH & Eva Insulation Cladding sheets through the hot flue gas (temp > 400 deg C) came out and burnt the Dried Insects which are Accumulated inside the Insulation and Cladding sheets

- The crack of the SH/Eva Top Duct Surface was welded and sealed. Now almost no more chances of insects/other organics ingress.
- The Insulation of the whole SH/Eva Top Duct Tube Headers were reassessed and completely sealed by converting the present

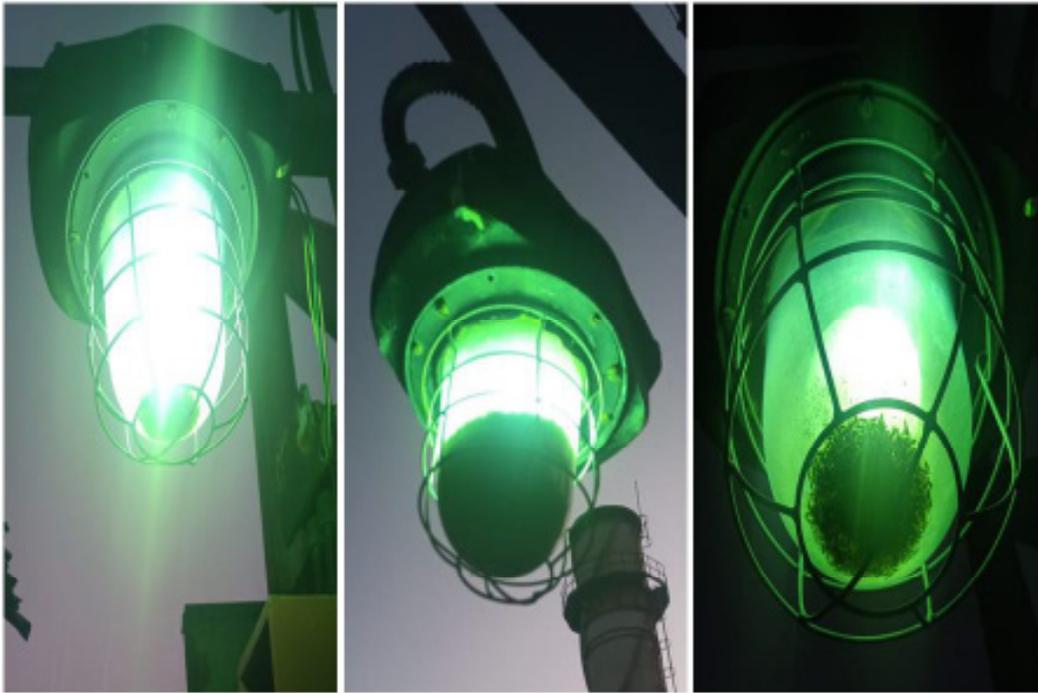
Figure 4: Dried Insects Inside the Earlier Hmpl (High Pressure Mercury Lamp) Area Bulbs In Hrsg-2

- The earlier HPML (high-pressure mercury lamps) area bulbs are replaced by more efficient and lesser insects' attraction LED bulbs in phase wise.

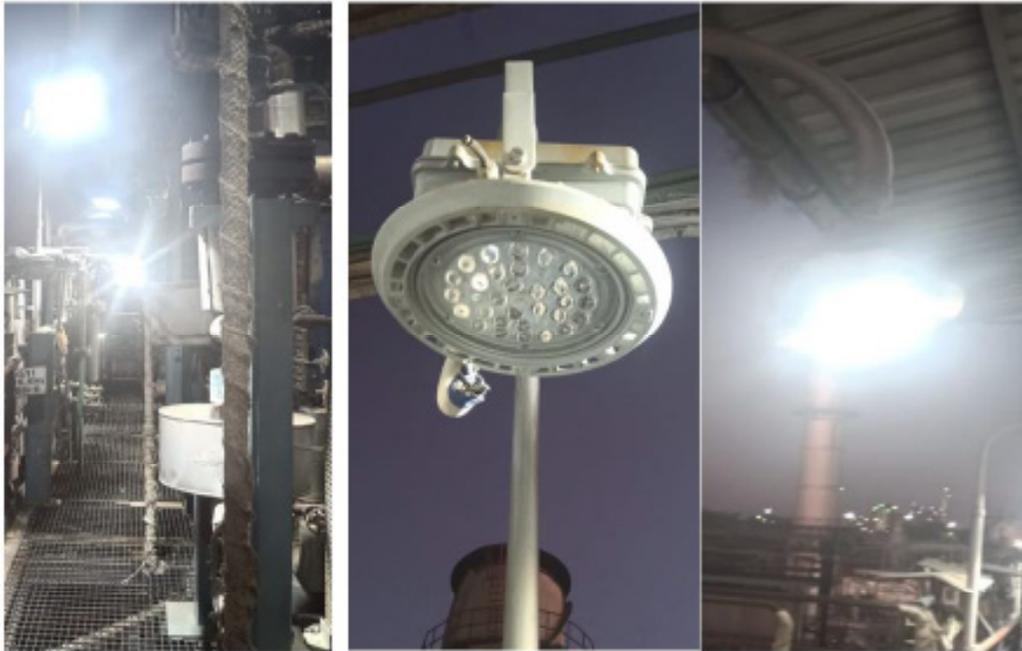
Figure 5: Earlier Hpml Now Replaced With More Efficient & Brighter Led Bulbs In Hrsg-2 (Now Much Lesser Chances of Insects or Organic Matters Accumulation)

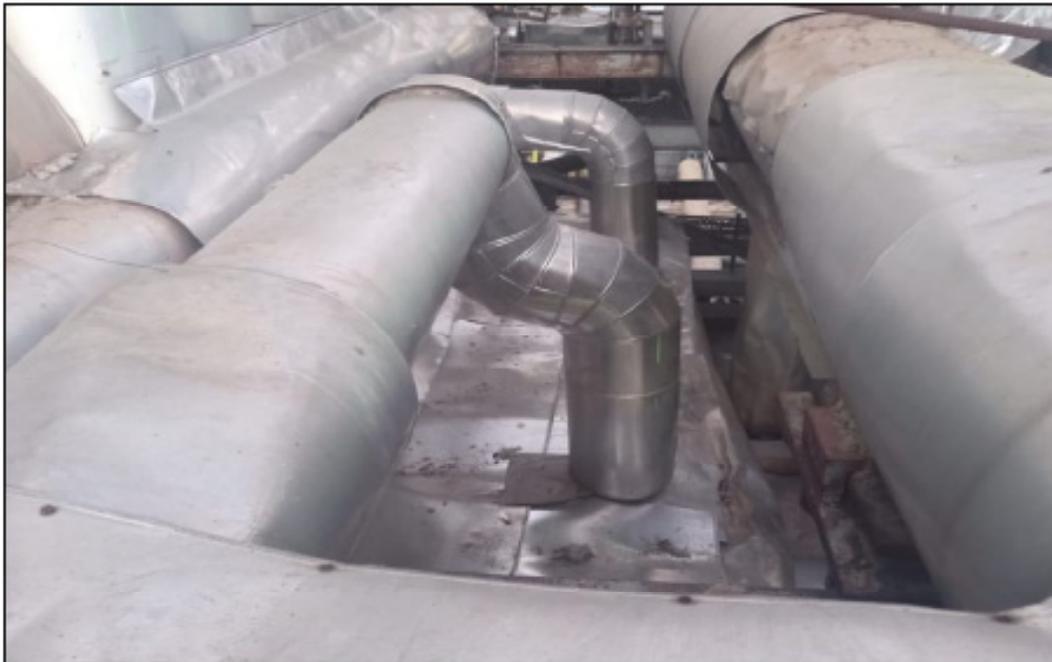
Figure 6: Box-Type Insulation Installed In Hrsg-2 For Better Sealing & Protection Against The Insects Ingress Inside The Cladding Sheets And Insulation Materials

insulation into a box-type insulation. Now almost no more chances of insects/other organics ingress.

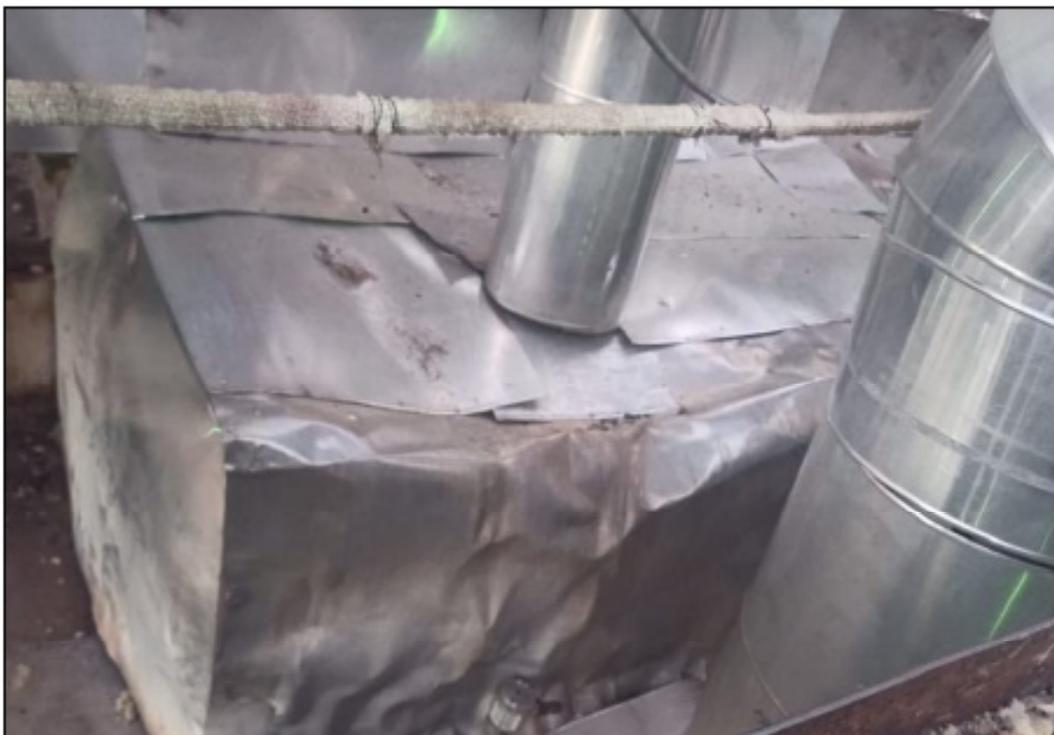
Figure 7: Box-Type Insulation Installed In Hrsg-2 For Better Sealing & Protection Against The Insects Ingress Inside The Cladding Sheets And Insulation Materials

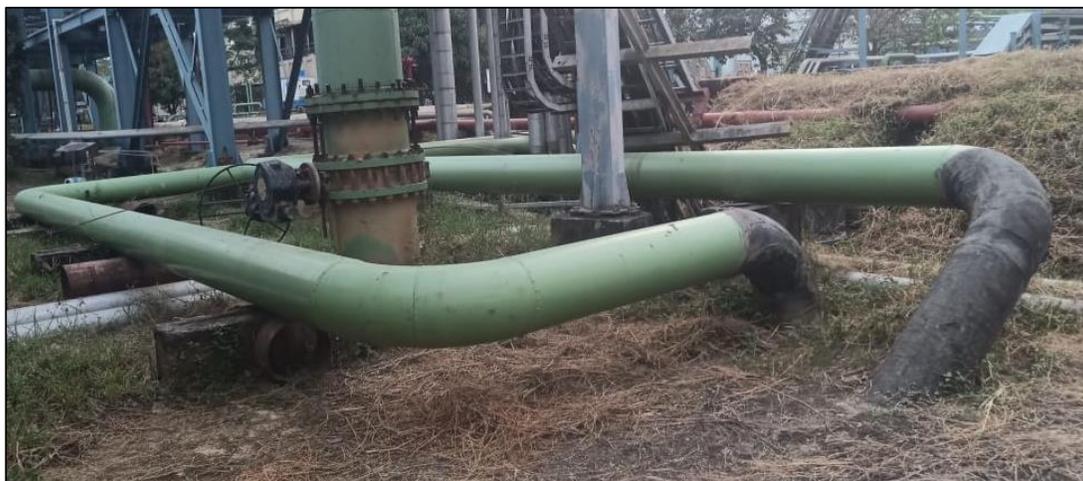
Figure 8: Cpp Cooling Water Supply & Return (Cws & Cwr) Converted From Earlier Underground To Now Over Ground For Easy Maintenance And Protection Against The Underground Corrosion And Leakage

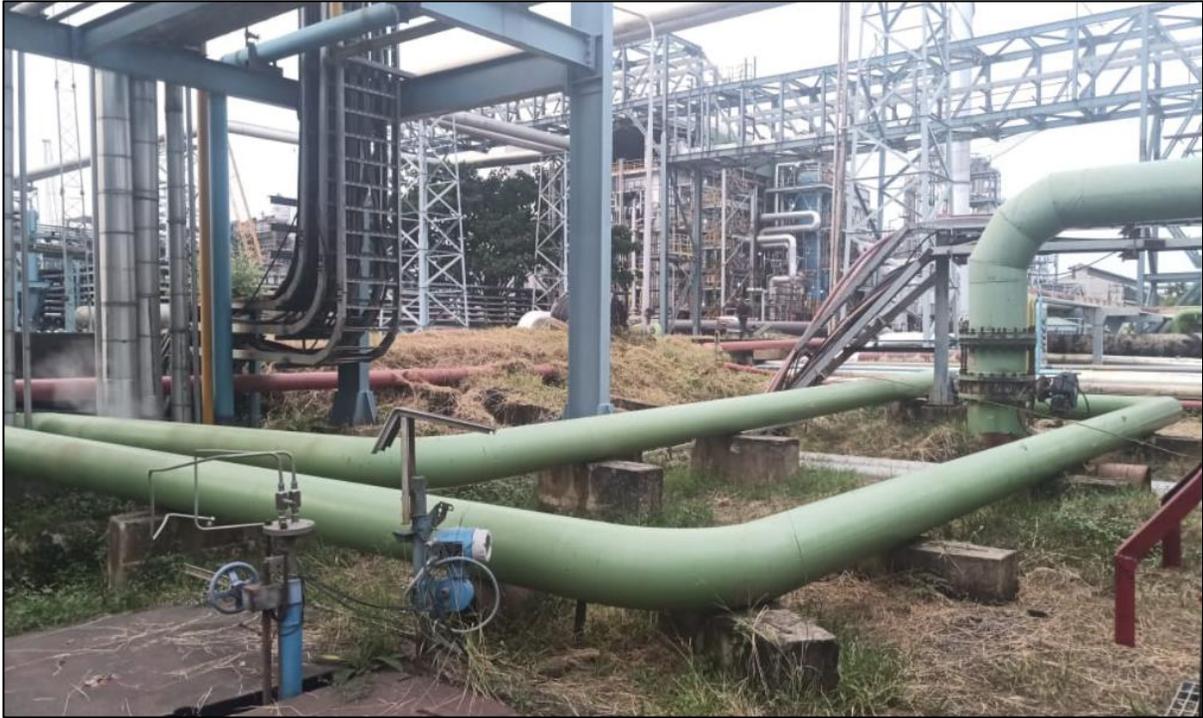
Figure 9: Cpp Cooling Water Supply & Return (Cws & Cwr) Converted From Earlier Underground To Now Over Ground For Easy Maintenance And Protection Against The Underground Corrosion And Leakage

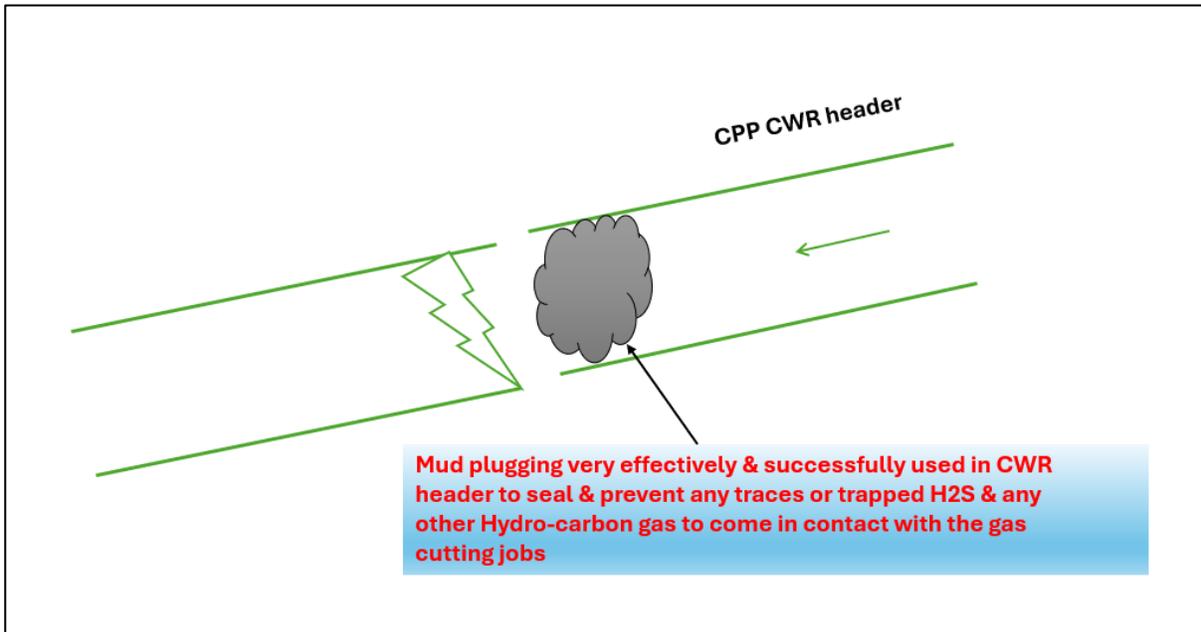
Figure 10: Mud plugging inside the CWR header just before the portion of the gas cutting was applied to double ensure that no more unseen trapped H2S gasses are completely cut-off

- Re-purging of the CWR circuits carried out with N₂ gas. H₂S checked at different locations. No H₂S found. Only intermittent H₂S was found at the hot job site. Complete purging carried out.
- The idea of Mud plugging inside the CWR header just before the portion of the gas cutting was applied to double ensure that no more unseen trapped H₂S gasses are completely cut-off. This method was very effective, and our hot jobs could be carried out successfully. Later on, the mud inside the CWR header was flushed out safely before charging the CWS & CWR circuits.

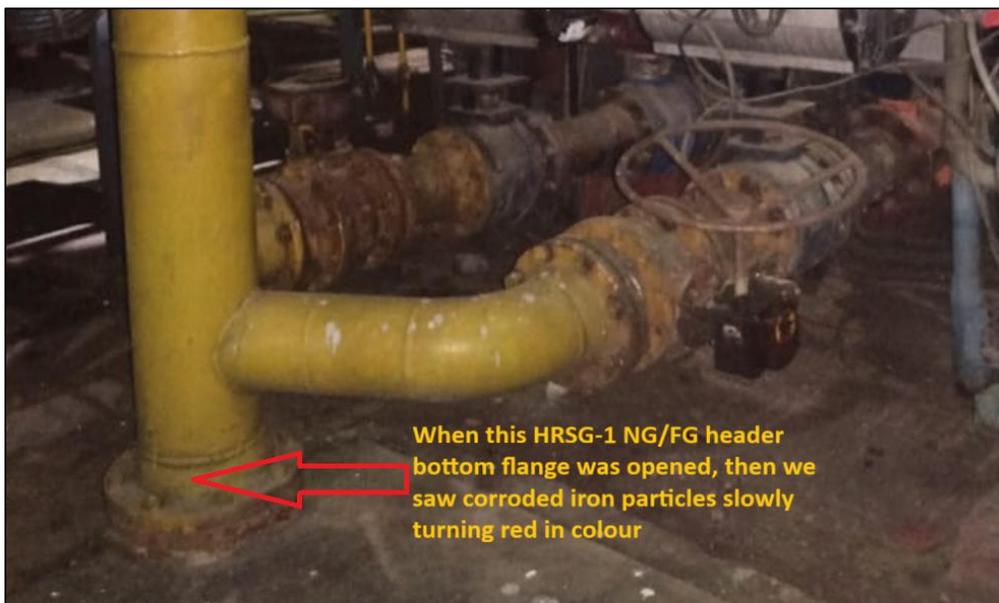
The Corrosion or fouling and the eroded iron particles inside the in the HRSG-1 NG/FG fuel header led to the formation of iron sulphide deposits. When the flange was opened, these deposits were exposed to air (oxygen). The reaction between these iron sulphide compounds, and oxygen likely triggered the fire. Oxidation of Iron Sulphide (Spontaneous Ignition) – Exothermic Reaction. The amount of heat can be enough to make the iron deposits glow red. Spontaneous ignition of pyrophoric materials caused a localized minor fire. While the iron itself cannot catch fire, if there is a fuel source present (e.g., residual oils, hydrocarbon gases), the heat created is adequate to ignite the fuel source, and fire must be avoided. When we open equipment (e.g., vessels, fuel gas lines) for maintenance, atmospheric air (oxygen) rushes in. FeS ignites spontaneously due to exothermic oxidation – generating heat, SO₂ gas (toxic) and potentially starting a fire.

Figure 11: HrsG-1 Ng/Fg Fuel Header Bottom Most Portion Flange When Opened, The Corroded Iron Particles Slowly Turned Red In Colour (Pyrophoric Iron Fire)

- Immediately the all the jobs were stopped, and FW was sprayed and wetted the iron particles.
- Then slowly the reddish fire like appearance disappeared.
- Then cleaning of the corroded iron particles was carried out with the Non-sparking tools.
- Again, N₂ purging was carried out.

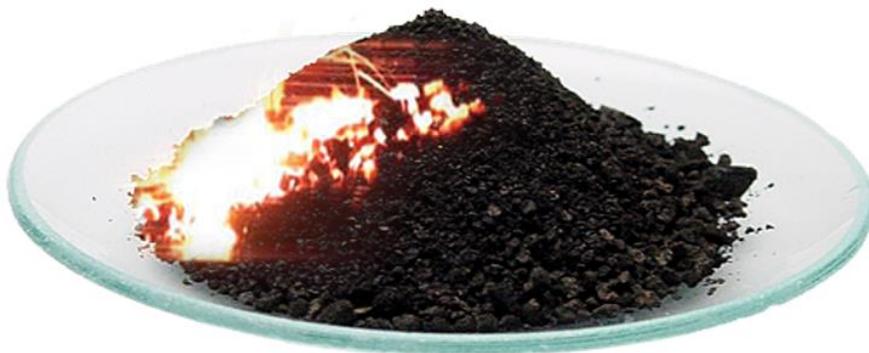
Figure 12: Picture Showing Pyrophoric Iron Fire

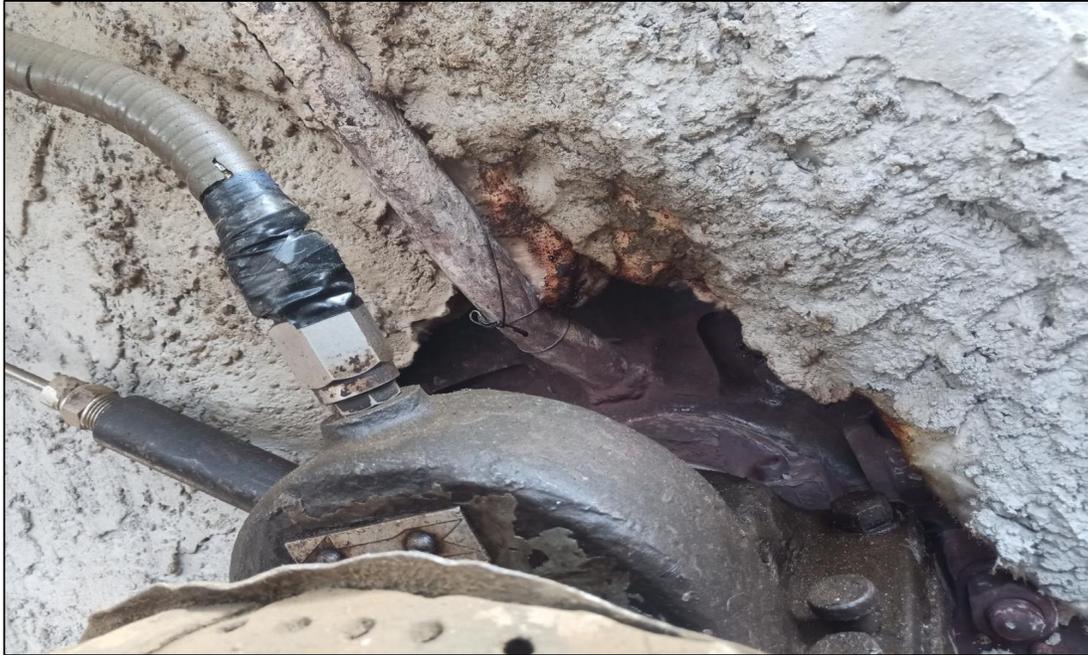
Sweating type minor Lube oil (LO) leakage near to the Turbine Governor & NDE Bearing housing, which for longer period of time accumulated inside insulation cover, which generated smoke after accumulation of sufficient oil and getting heated to flash point from the hot surface/body of running turbine.

Figure 13: Lo Leakage From The Turbine Lo Bearing Housing & Governor

- Immediately the stand-by Cooling Water motor driven pump was started and the affected CW Turbine 25-PT-02E was stopped by activating the Emergency Shut-off mechanism.
- DCP was sprayed.
- Informed F&S Team. They immediately reported at site. They also sprayed DCP & one CO₂ cylinder. Slowly the fire and the smoke was contained safely.
- The Turbine thorough healthiness checking was carried out. The LO leakage source was identified and arrested.

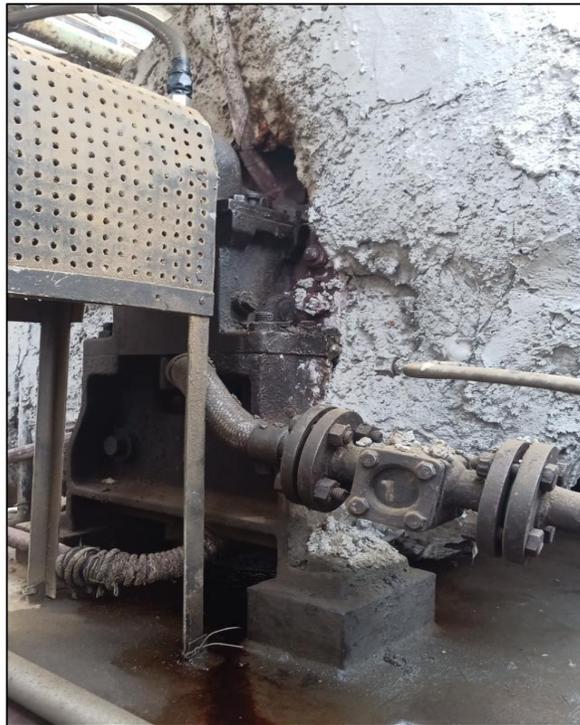
Figure 14: Lo Leakage From The Turbine Lo Bearing Housing

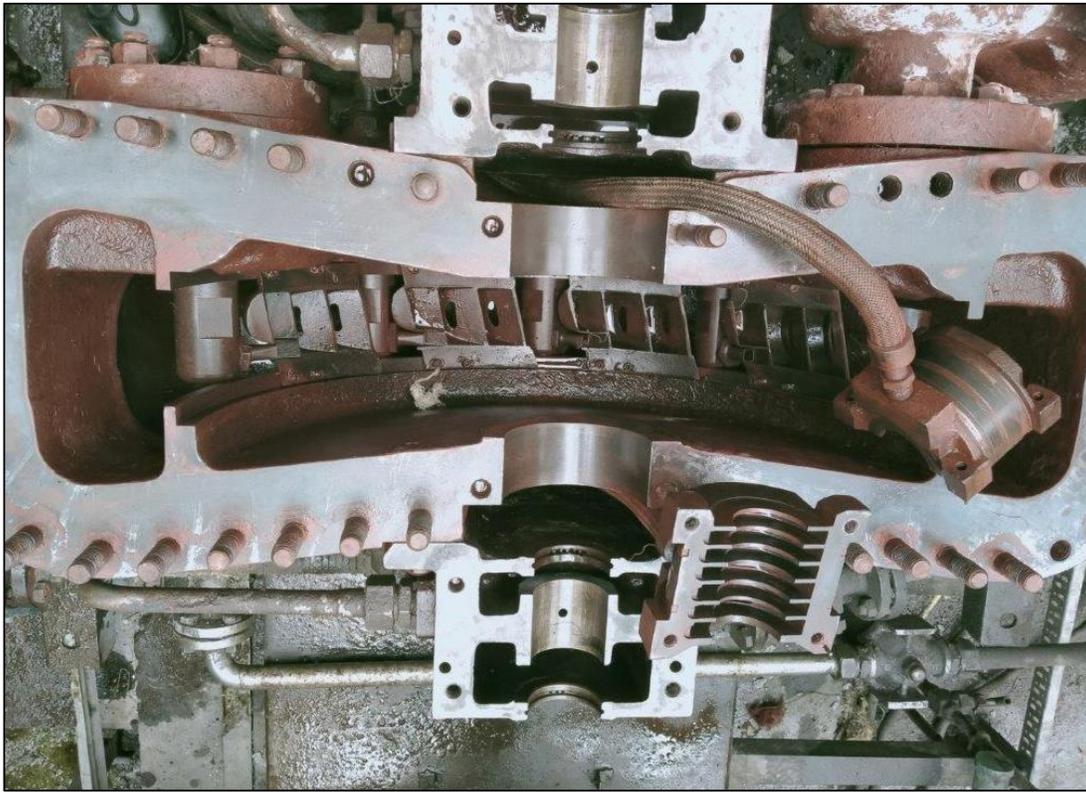
Figure 15: Turbine Internals Thorough Checked, Servicing & Preventive & Thorough Healthiness Checking Done
